Installing 2-sided floppy drive into Philips VG-8230

Fix created by RepairBas, pictures and testing by Wierzbowsky [RBSC]

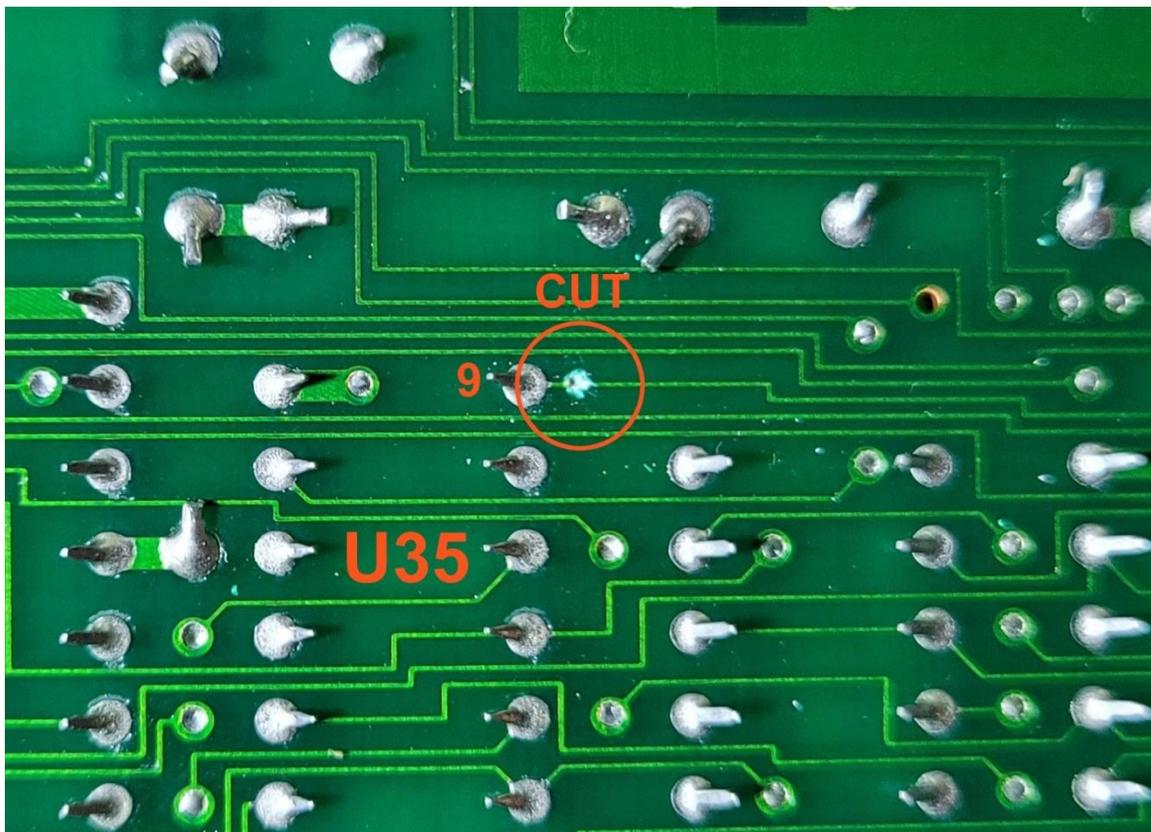
After the new disk BIOS and 2-sided floppy drive gets installed, it will be possible to use 720kb floppy disks, however, booting to MSX-DOS will be not possible yet. The fact is that the VG8230's motherboard has a hardware bug with memory management that prevents the MSX-DOS from booting correctly. This was one of the reasons why Philips came up with 8235/00 computer soon after releasing VG8230. To fix the problem with the motherboard it's necessary to perform a few changes. The description is below.

Now it's necessary to make a few cuts on the motherboard. A cut can be made with a sharp knife. Make sure that you don't damage any other tracks when making the cut. First, cut the track that goes to pin 9 of U35 chip on the bottom side of the motherboard as shown on this picture:
